November 3, 2017

Subject: Structural Observation of 0000 Smith Rd, IL  
Job Number: 2017-33

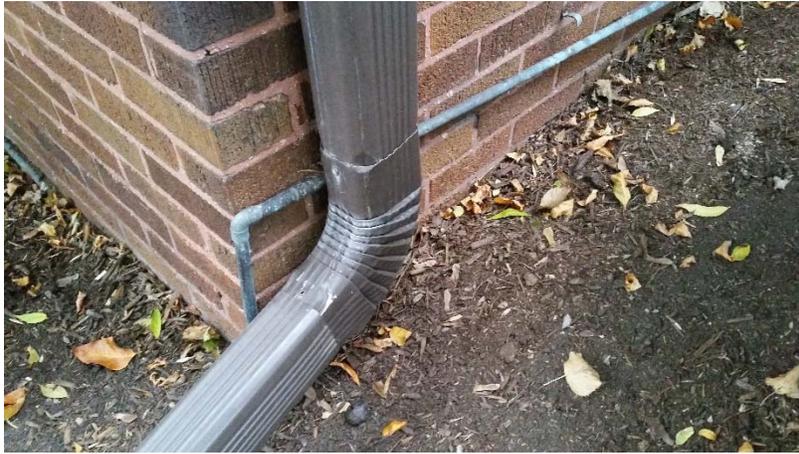
From the exterior of the property, the foundation walls cannot be seen in some locations and the grade/soil is against the brick façade. See photos 1, 2, and 3. The brick will deteriorate from constant contact with the ground. **The grade needs to be lowered so that the foundation is a minimum of 4" above grade/soil in all locations.**

Photo 1: High grade in the southeast corner of the house

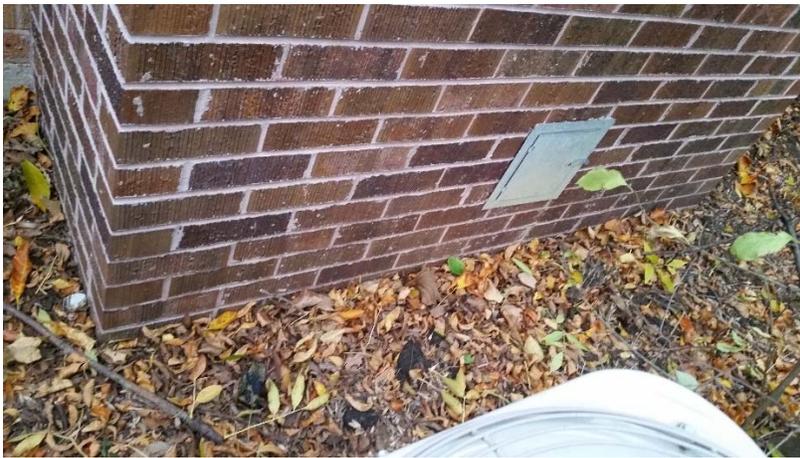
Photo 2: High grade on the southwest side of the house

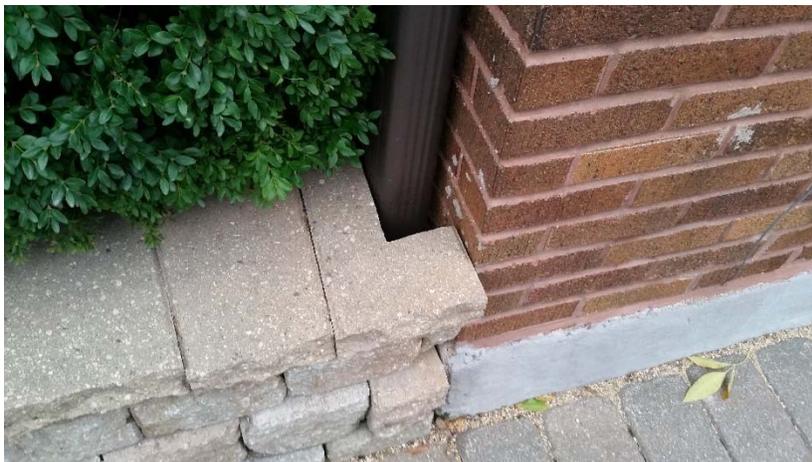
Photo 3: High grade on the northeast side of the house

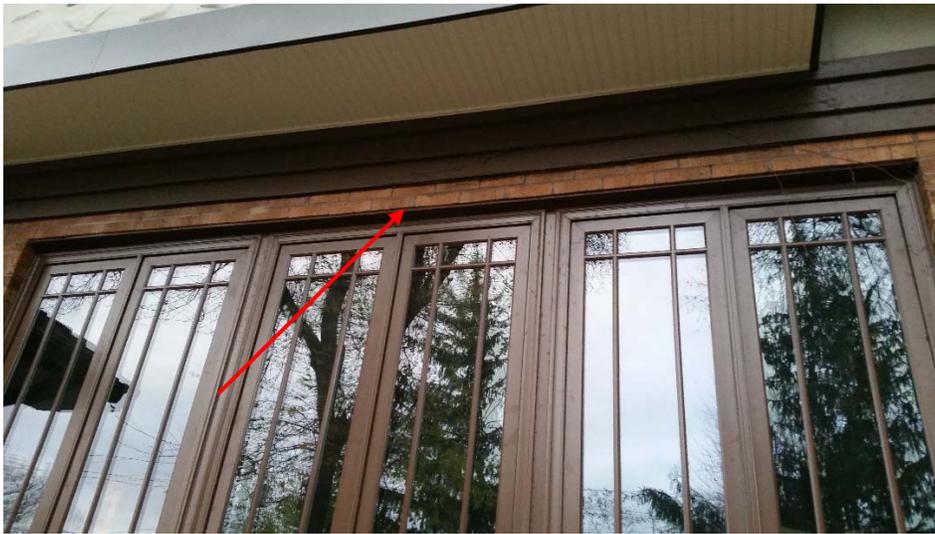
There are steel lintels supporting the exterior brick façade above the window and door openings in the brick façade. See photo 4 for a typical lintel. All the lintels were well maintained, however the lintels at the basement windows on the north side of the house and the window shown in photo 5 were showing initial signs of rusting. When water is allowed to come in contact with the steel lintel it causes the lintel to rust. When steel rusts, it expands to many times its initial size. Overtime this will cause the masonry above the window to be pushed out and eventually the lintel will deflect and fail.

Photo 4: Steel Lintel above rear window

**I recommend that these lintels and any others be maintained.** Paint needs to be applied to any exposed portions of the steel. Mortar needs to be applied in any decaying brick mortar joints where the lintel bears on the masonry. The horizontal joint between the masonry and steel above the window should not be caulked, but should have weep holes or a crack so that water is allowed to drain. Masonry is a porous material and naturally lets water behind it. The water drains down and without weep holes, ponds on the steel lintels. Weep holes allows water to drain out of the wall.

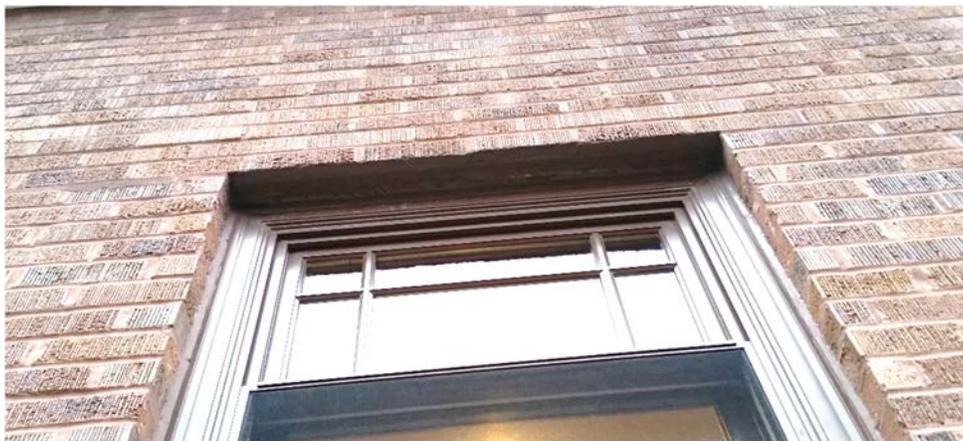
Photo 5: Lintel on the north side of the house

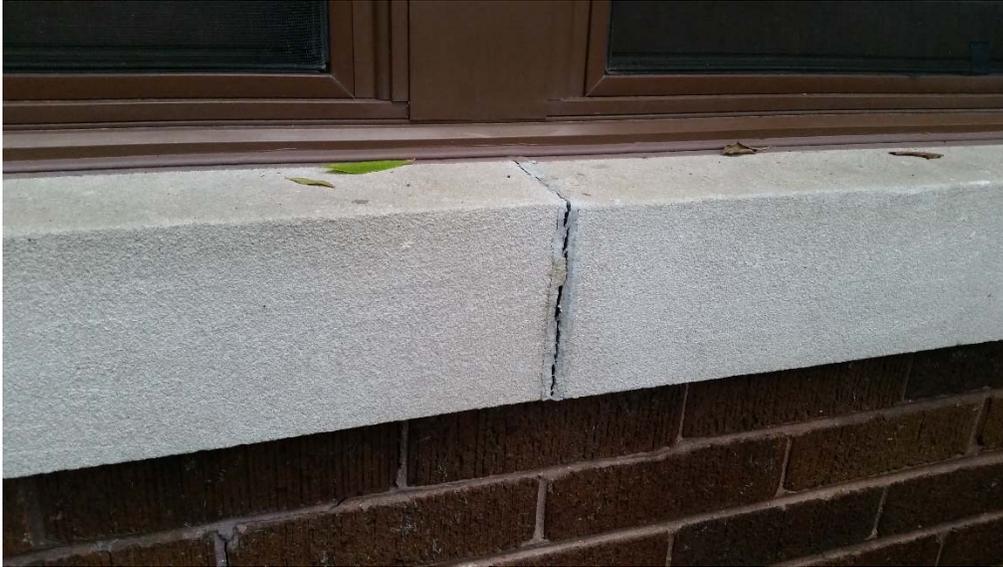
Water is entering behind the masonry at the window sill shown in photo 6 and causing the cracks in the masonry below shown in photo 7. When water leaks behind the masonry it freezes, expands, and causes the masonry to crack and be pushed out. **I recommend that this window sill is sealed by a qualified contractor so that water is not allowed to penetrate the masonry wall and further damage the masonry.**

Photo 6: Crack in window sill on the south window on the east façade

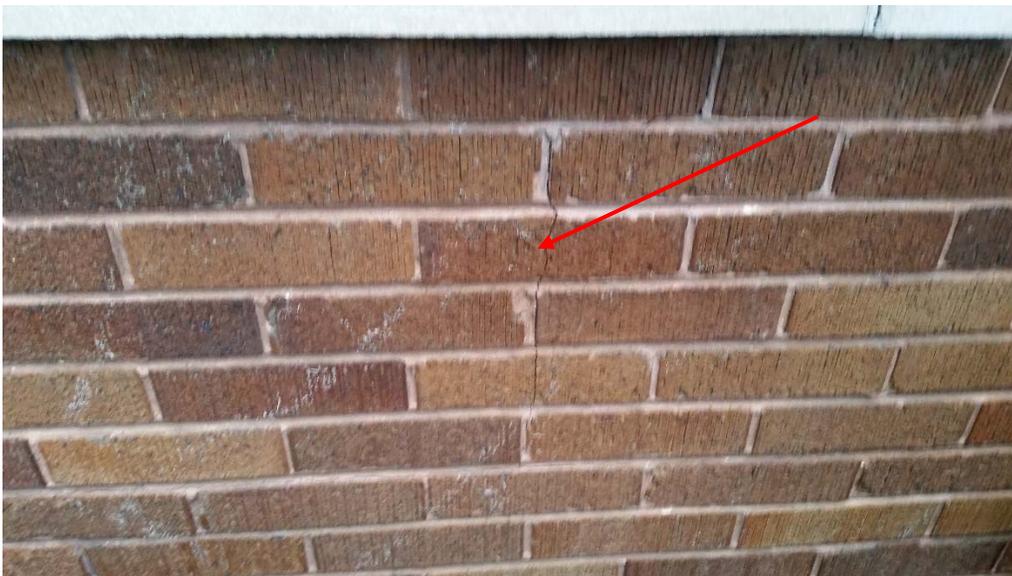
Photo 7: Crack in masonry below cracked window sill

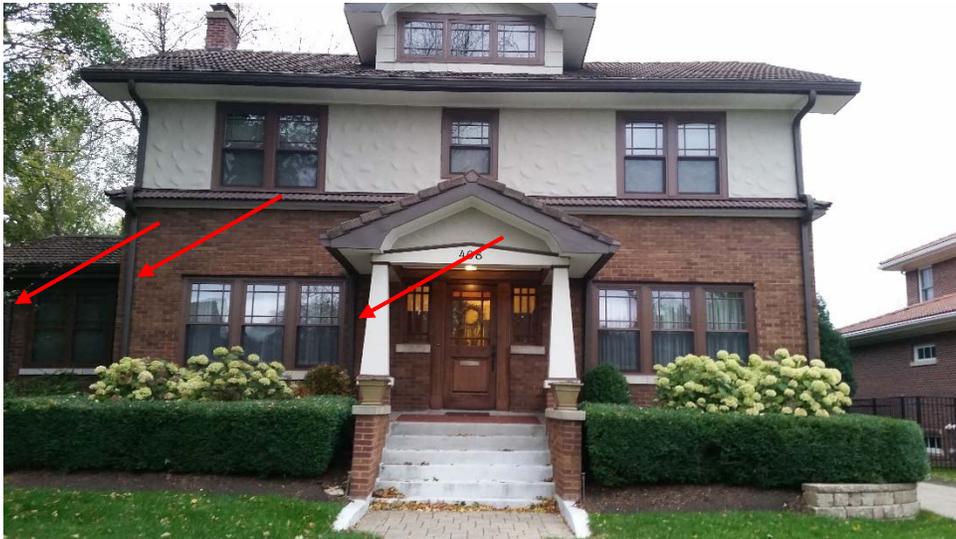
1. The (3) downspouts located on the south side of the east façade (see photos 8, 9, and 10 and 11)
2. The downspout located on the south side of the house (see photo 12)

Photo 8: East façade with poorly draining downspouts

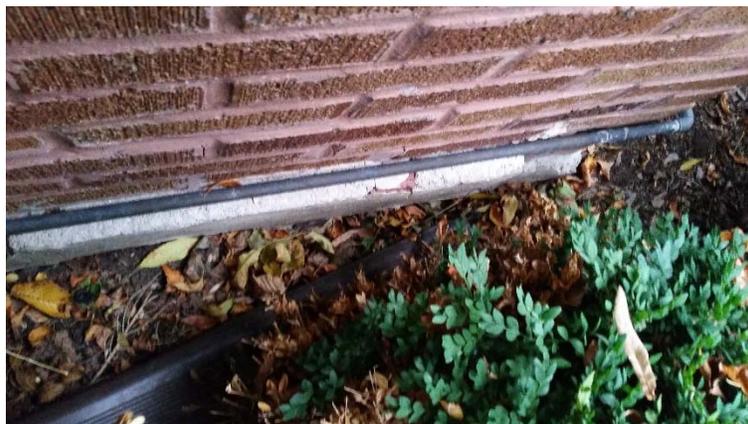
Photo 9: Downspout empties behind porch wall on east Façade

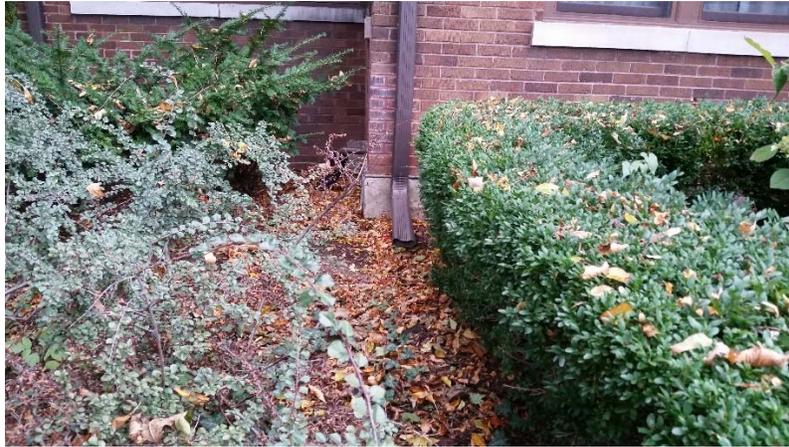
Photo 10: Downspout empties too close to the existing foundation

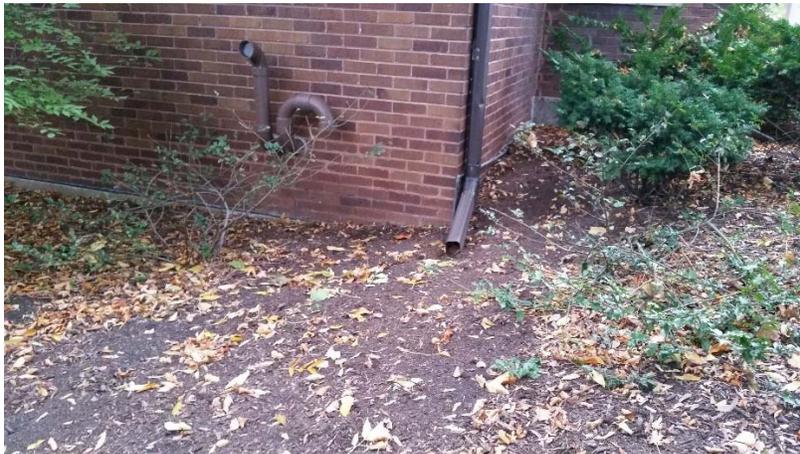
Photo 11: Downspout empties too close to the existing foundation

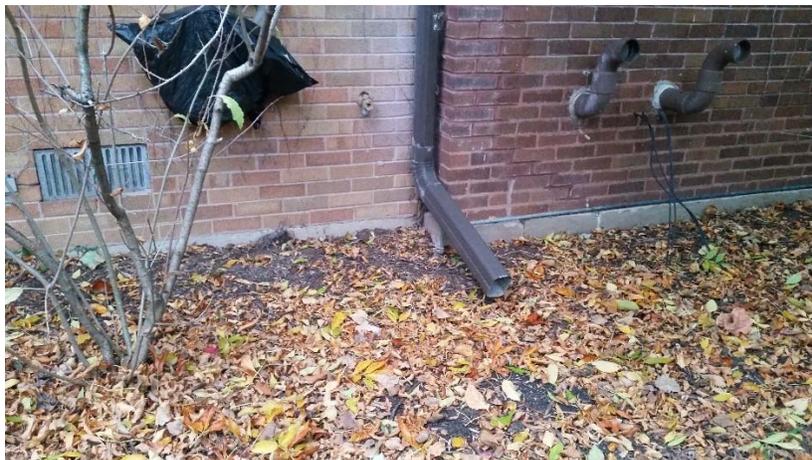
Photo 12: Downspout empties too close to the existing foundation

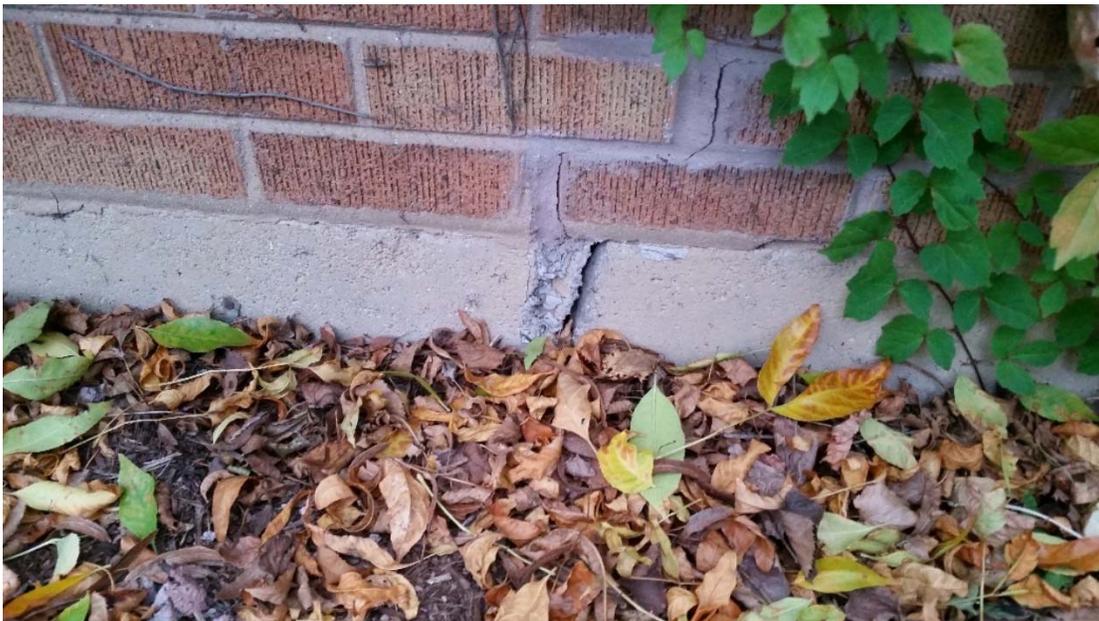
The southwest corner of the house has settled. Evidence of such settlement is the slope of the first-floor family room and the second-floor bedroom toward the southwest corner of the house. Additional evidence is the stair step crack shown in photo 13.

I do not believe that this settlement is typical settlement. The crack shown in photo 13 has a narrow mortar joint at the bottom and the mortar joints widen further up the wall. Additionally, there also looks like there have been multiple repairs in this area.

Photo 13: Crack in southwest corner of the house on the west façade

Because this settlement is very localized I believe it is caused by a weakening of the soil caused by poor drainage and worsened by the weight of the chimney. **I recommend that the downspout at this corner is checked for proper drainage and cracked pipes below the grade then any area of ponding or broken pipe is repaired.** I believe that proper drainage in this area will stop the continued settlement. If the drainage is not fixed I believe that the settlement will continue. **If the settlement does not stop with proper drainage, piers should be installed.**

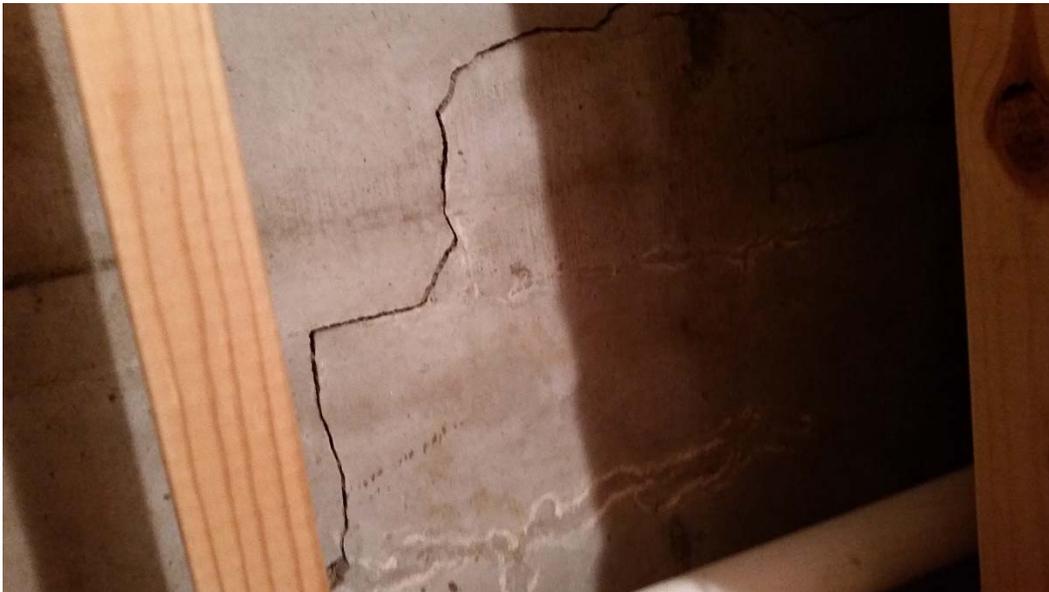
There were several large cracks in the east basement wall (see photos 14 thru 16) but the large concrete footing under the wall that was installed when the basement was dug out is not cracked. Therefore, I do not believe that the cracks are due to settlement. I believe that the cracks are from an increased load behind the basement wall because of the poor drainage on the east façade. Water behind the wall significantly increases the load on the foundation wall and caused it to crack.

Photo 14: Crack in the north side of the east foundation wall

**I recommend that the masonry walls are repaired. A qualified mason should inspect these walls and scrape away all deteriorating mortar then prepare the crack as required, including cleaning all loose debris from the crack. Finally, the mason should fill the entire depth of the crack with mortar. If this is not done water can penetrate the foundation, freeze, and crack the foundation even further.**

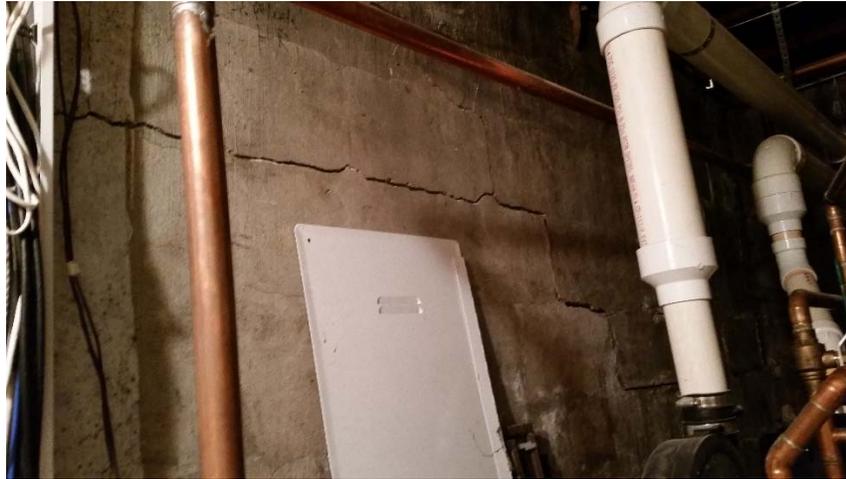
Photo 15: Cracks in the south side of the east foundation wall

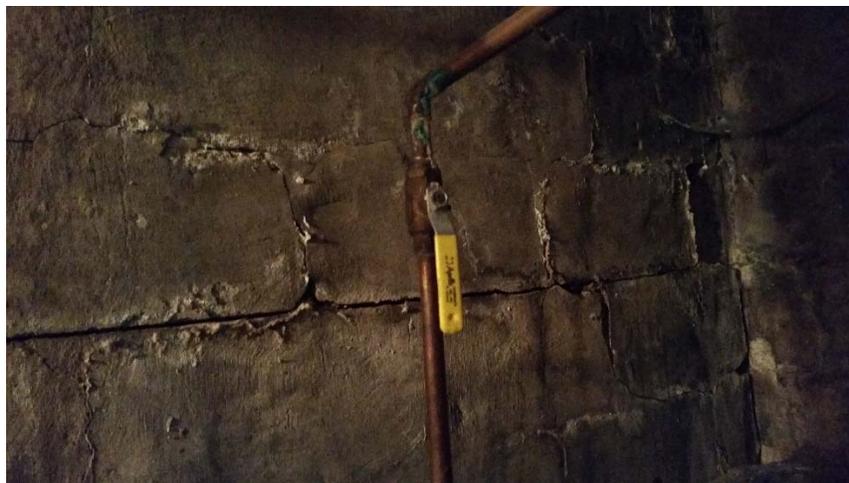
Photo 16: Cracks in the south side of the east foundation wall

Efflorescence was observed on some of the masonry (see photo 16). The efflorescence itself does not compromise the structural integrity of the brick and can be cleaned off with soap and water. However, it is a salt and mineral white powdery deposit that is formed when water is allowed to seep through the brick. The water seepage is a problem and will cause the masonry to deteriorate. **I recommend that any places where efflorescence is seen is watched for a potential water issue/leak and the point of water infiltration is repaired.**

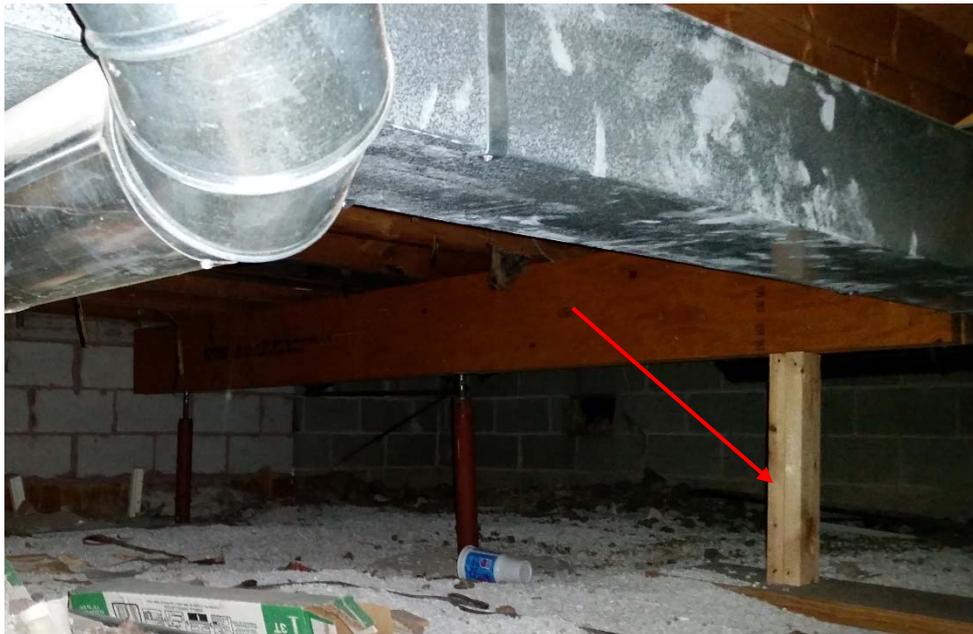
There is a glulam beam in the crawlspace under the addition to the back of the house. This glulam beam was cut to allow mechanical vents through. When the beam was cut, and adequate foundation was not installed (see photo 17). **I recommend that the wood posts and wood footing is replaced with a steel column and a concrete footing.**

Photo 17: Wood post under addition floor
